Manhole Inspection Summary

Manhole # S31AA2006MH

Insp Date: **4/17/07 10:22 AM**

Location Address: **107 CROYDON RD**

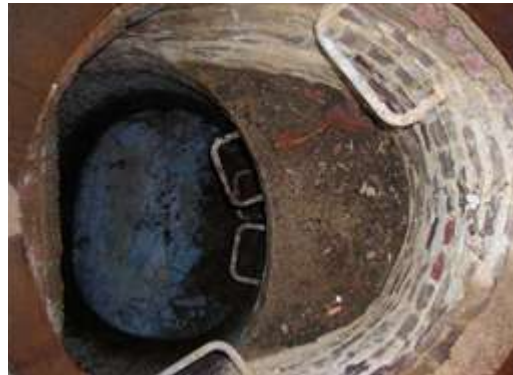
Top View

☒ **Debris** (not Condition related)

Channel debris.

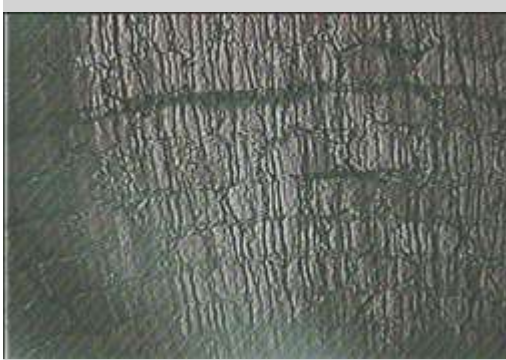
Defect

Condition: ☐ Sound ☐ Cracked ☐ Root Intrusion ☐ Loose Brick ☒ **Deteriorated**

Infiltration: ☐ None ☐ Joint ☐ Cracks ☒ **Mortar** ☐ Roots ☒ **Wall**

Barrel deterioration and infiltration.

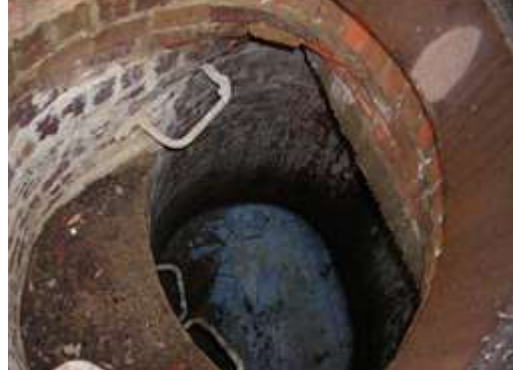
Defect

☒ **Leaks**

Infiltration: ☐ None ☒ **Joint** ☐ Cracks ☐ Mortar ☐ Roots ☒ **Wall**

Frame leaks. Adjustment and Barrel infiltration.

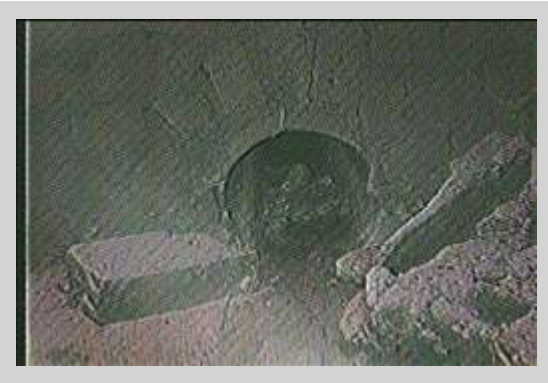
8 in. Circular Gravity Sewer
Pipe Out @ 12 O'Clock

Deposits: ☐ None ☒ **Mud** ☐ Sludge ☒ **Debris** ☒ **Grease**

Silt Depth: **1** (in.) Deposits Extent: **Light**

Infiltration: **Evidence** Pipe Seal Cond: **Cracked**
